UNIVERSITY OF CALIFORNIA LICK OBSERVATORY		ADC STAGE KECK ADC	
DES'N BY: B. Alcott	ORIGIN DATE: 09-16-03	DWG. NO.	NUM. 4 OF 6
Last SN	MODIFY DATE: 02-22-07	EL-3610	REV. A
PRINT TIME: 09:24:24	PRINT DATE: Mon Mar 12, 2007		
PATH: ADC\		ADC_stage.sch

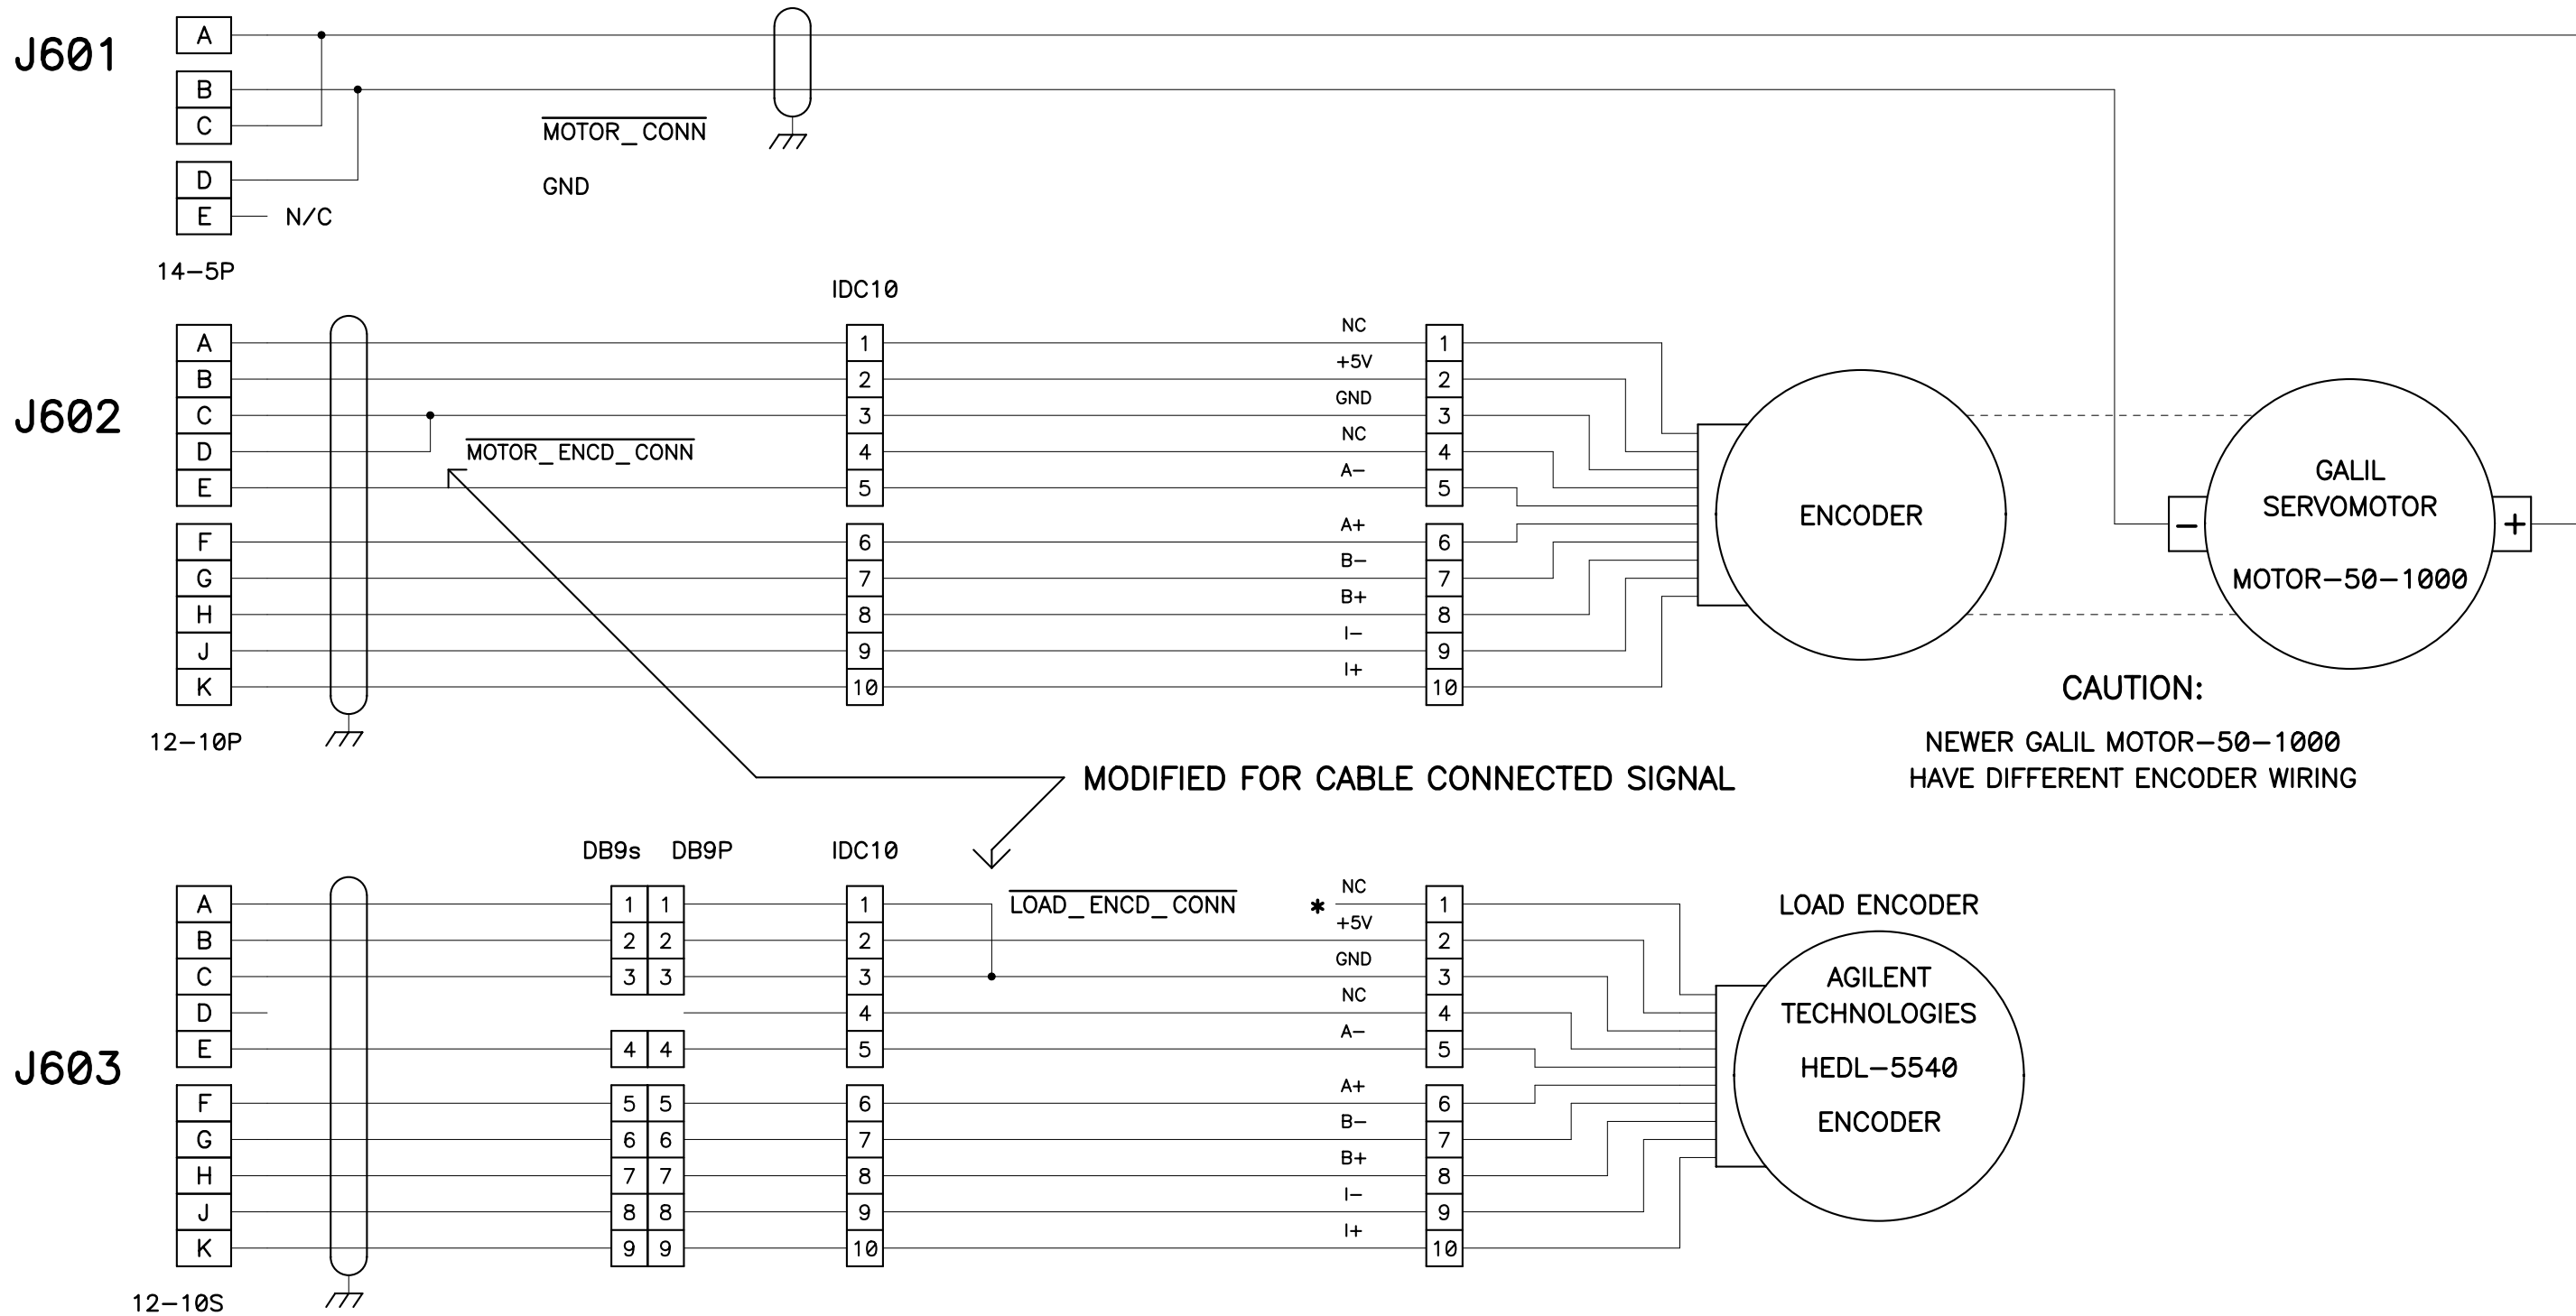
CAUTION:
NEWER GALIL MOTOR-50-1000
HAVE DIFFERENT ENCODER WIRING

MODIFIED FOR CABLE CONNECTED SIGNAL

***ENCODER MODIFICATIONS:**
TO ENSURE THAT THE ENCODER CONNECTED SIGNALS REMAIN UNIQUE, THE MOTOR AND LOAD ENCODER WIRING HAS BEEN MODIFIED. IN EACH CASE, THE GND SIGNAL COMING INTO THE ENCODER HAS BEEN WIRED BACK TO ONE OF TWO UNUSED PINS. THESE PINS ARE THEN WIRED BACK TO TWO OF THE CONTROLLER'S EXTENDED I/O INPUTS. THIS ALLOWS THE CONTROLLER TO DETERMINE IF EITHER ENCODER IS DISCONNECTED.
